# Monitoring Survey at the Isles of Shoals North Disposal Site, August/September 2022

## Disposal Area Monitoring System - DAMOS

Contribution 217  
December 2023

INSPIRE Environmental  
513 Broadway  
Newport, RI 02840

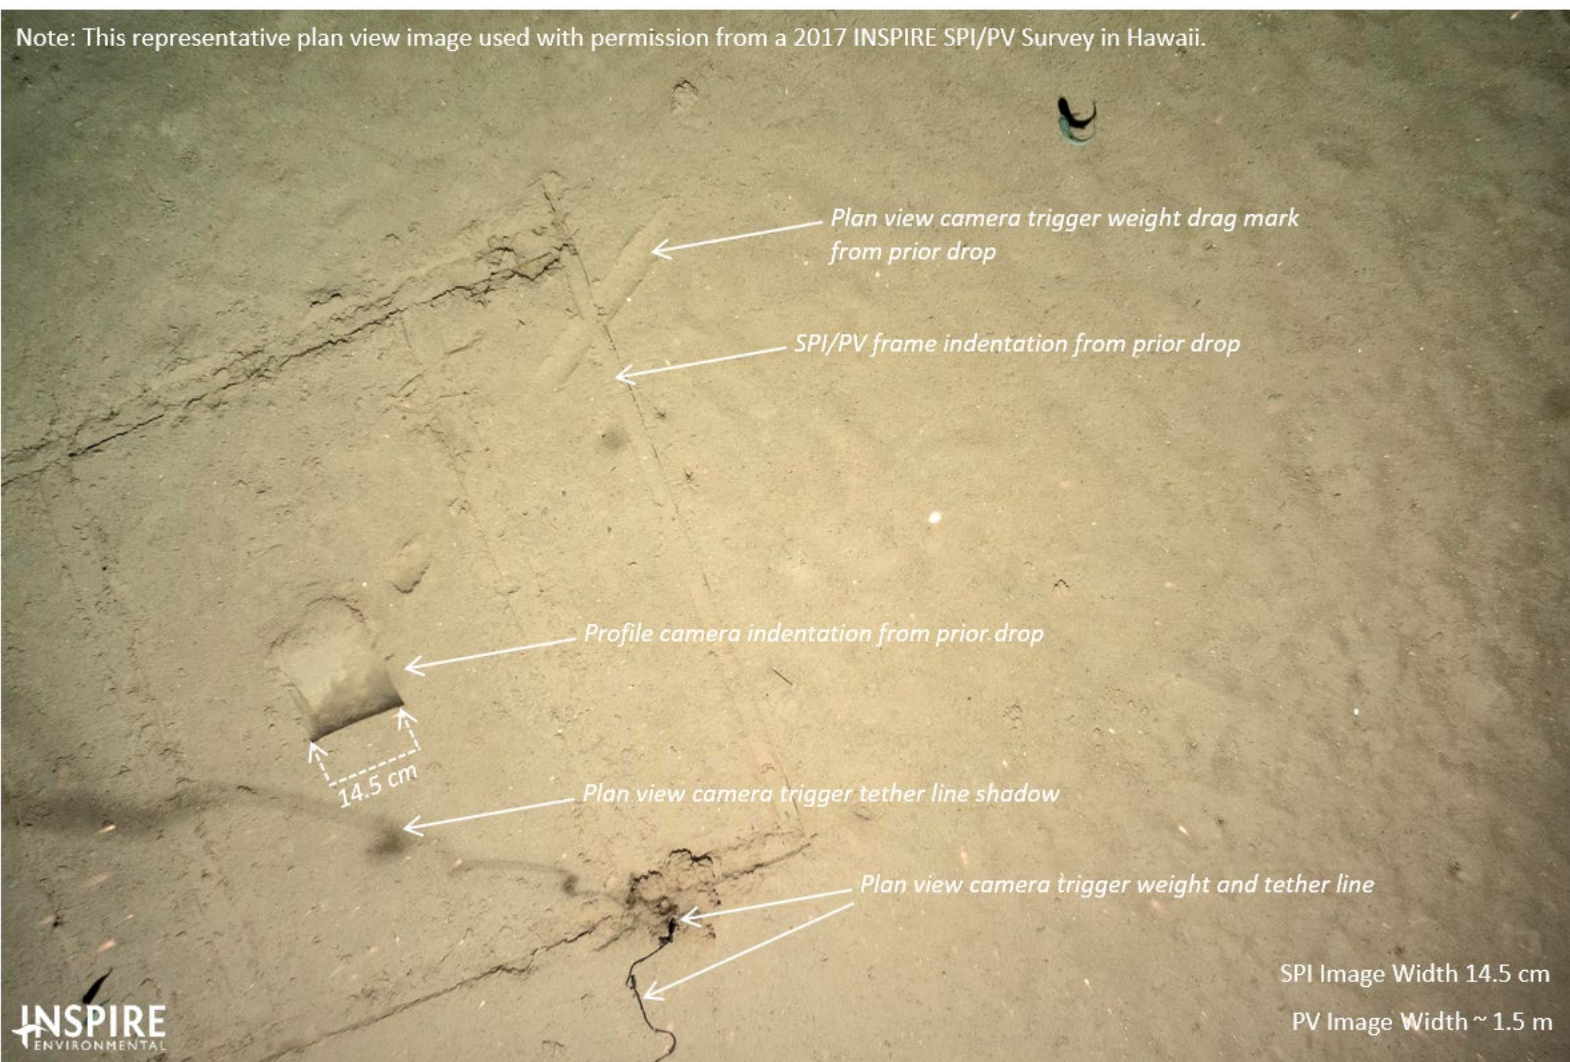
Figure 2-6. This representative plan view image shows the sampling relationship between plan view and sediment profile images. Note: plan view images differ between surveys and stations and the area covered by each plan view image may vary slightly between images and stations.
